Building & Pest Inspection Report

Building & Pest Inspection

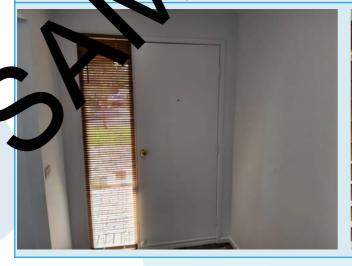
Entry, it has been observed that the door appears to be binding on the top left-hand side of the door jamb.

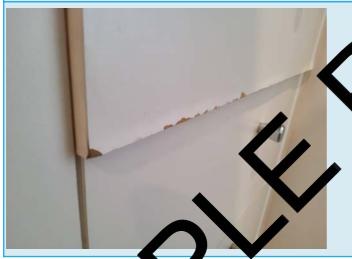
It has been observed that the shelving/cabinet below the sink appears to be water damaged.

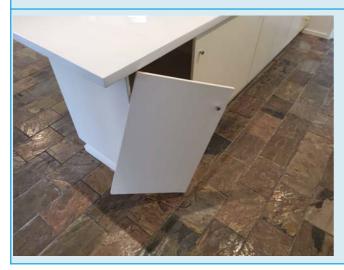
It has been observed that the hinge associated with the bottom left hand side cabinet door, appears to have become detached from the door.

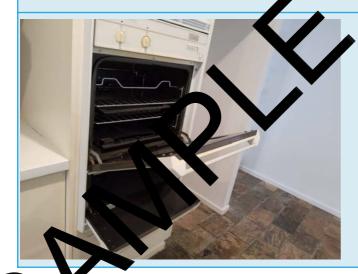
It has been observed that the oven door is difficulate fully open, a ppears the hinges are binding on the oven frame.

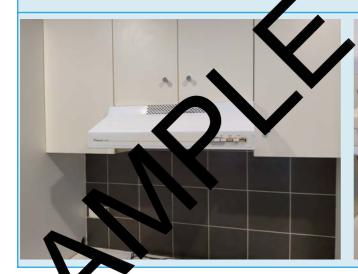
It has been observed that the plastic cover for the rangehood lightlight switch off button appears to be damaged.

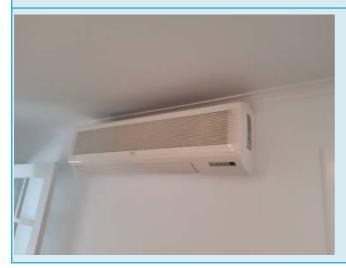
It has been observed that the split system appears not to be engaging, when attempted to connect with the wireless remote controller.

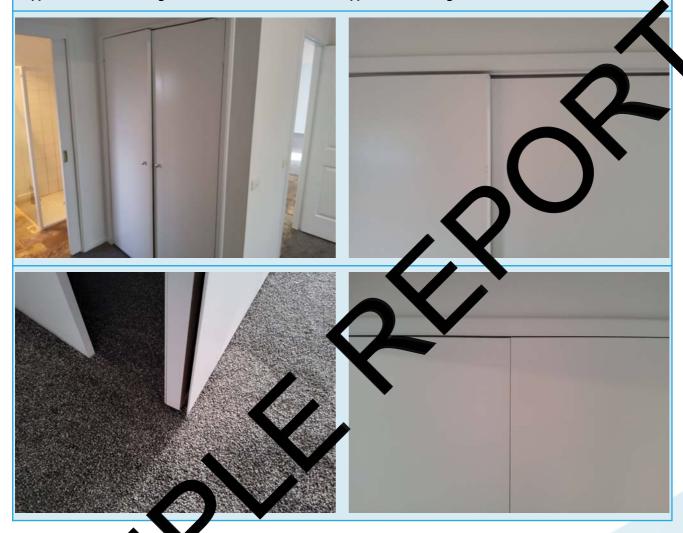
It has been observed that the right hand side robe doors appeared to be misaligned, the front and rear skins of the door appear to be delaminating and the left hand side robe doors appear to be binding.

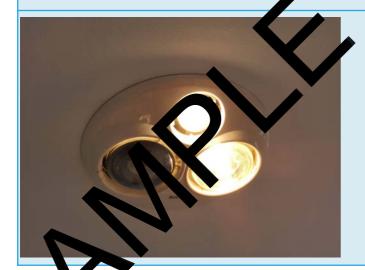
It has been observed that one of the heat lamps to the IXL appear to be burned out.

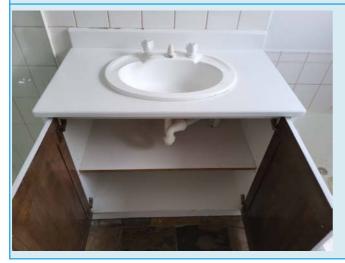
It has been observed that the shelving/cabinet below the basin appears to be water damaged.

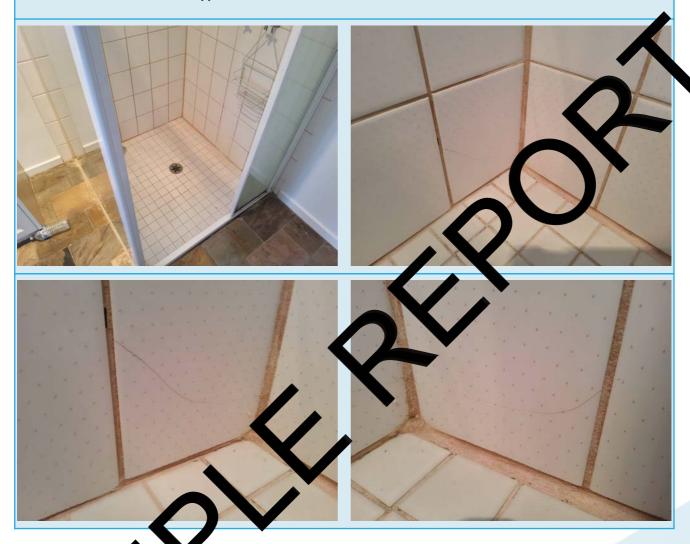
It has been observed that there appears to be 2 cracked wall tiles located to the bottom corner of the shower recess area.

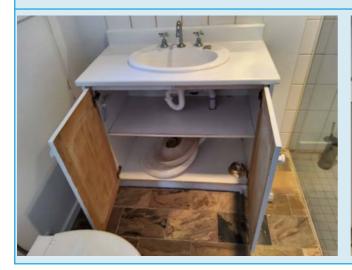
It has been observed that the shelving/cabinet below the basin appears to be water damaged.

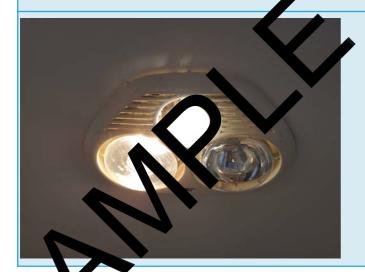
It has been observed that one of the heat lamps to the IXL appear to be burned out.
